# FLIGHT TEST EVALUATION OF OH-58A TAILBOOM FAILURE DURING AUTOROTATION LANDINGS

Thomas L. Sanders  
BELL HELICOPTER COMPANY  
Post Office Box 482  
Fort Worth Texas 76101

14 March 1973  
Final Report

REPORT No. 206-194-134

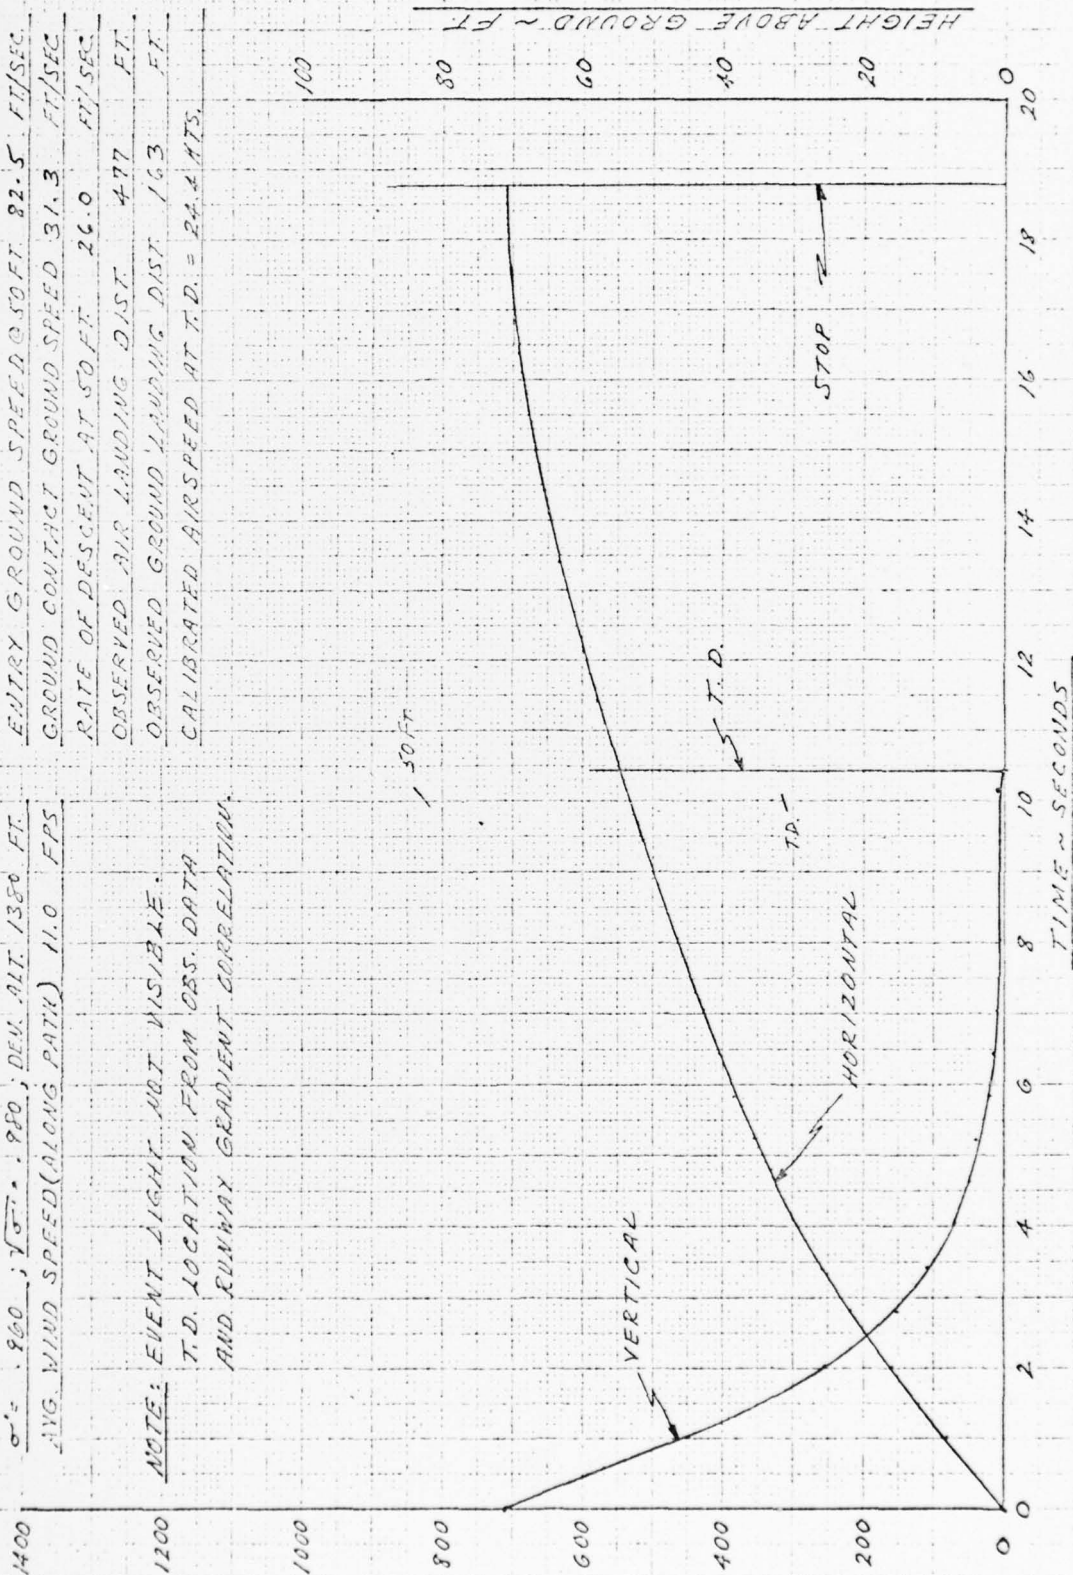
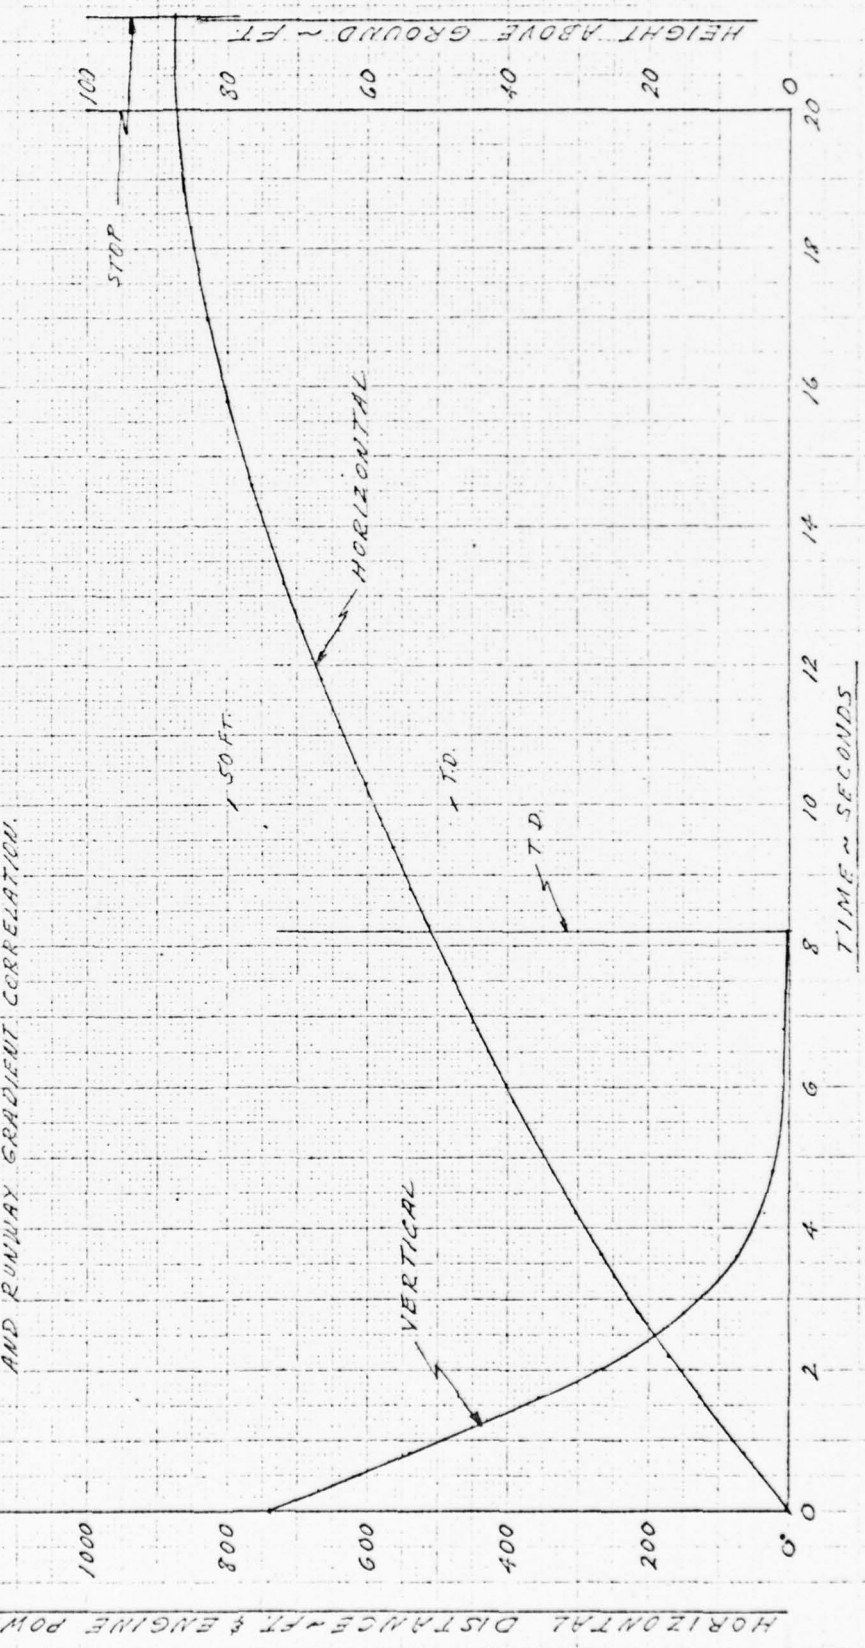
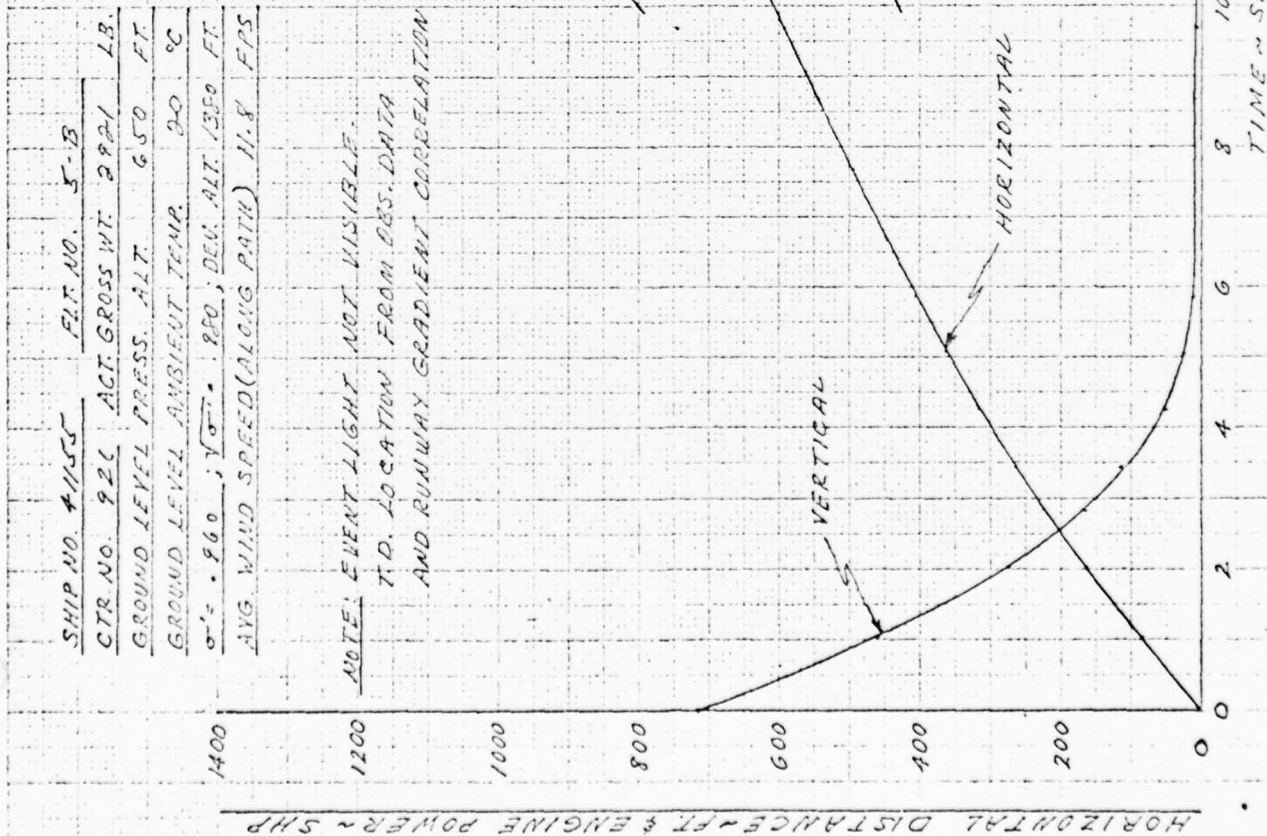
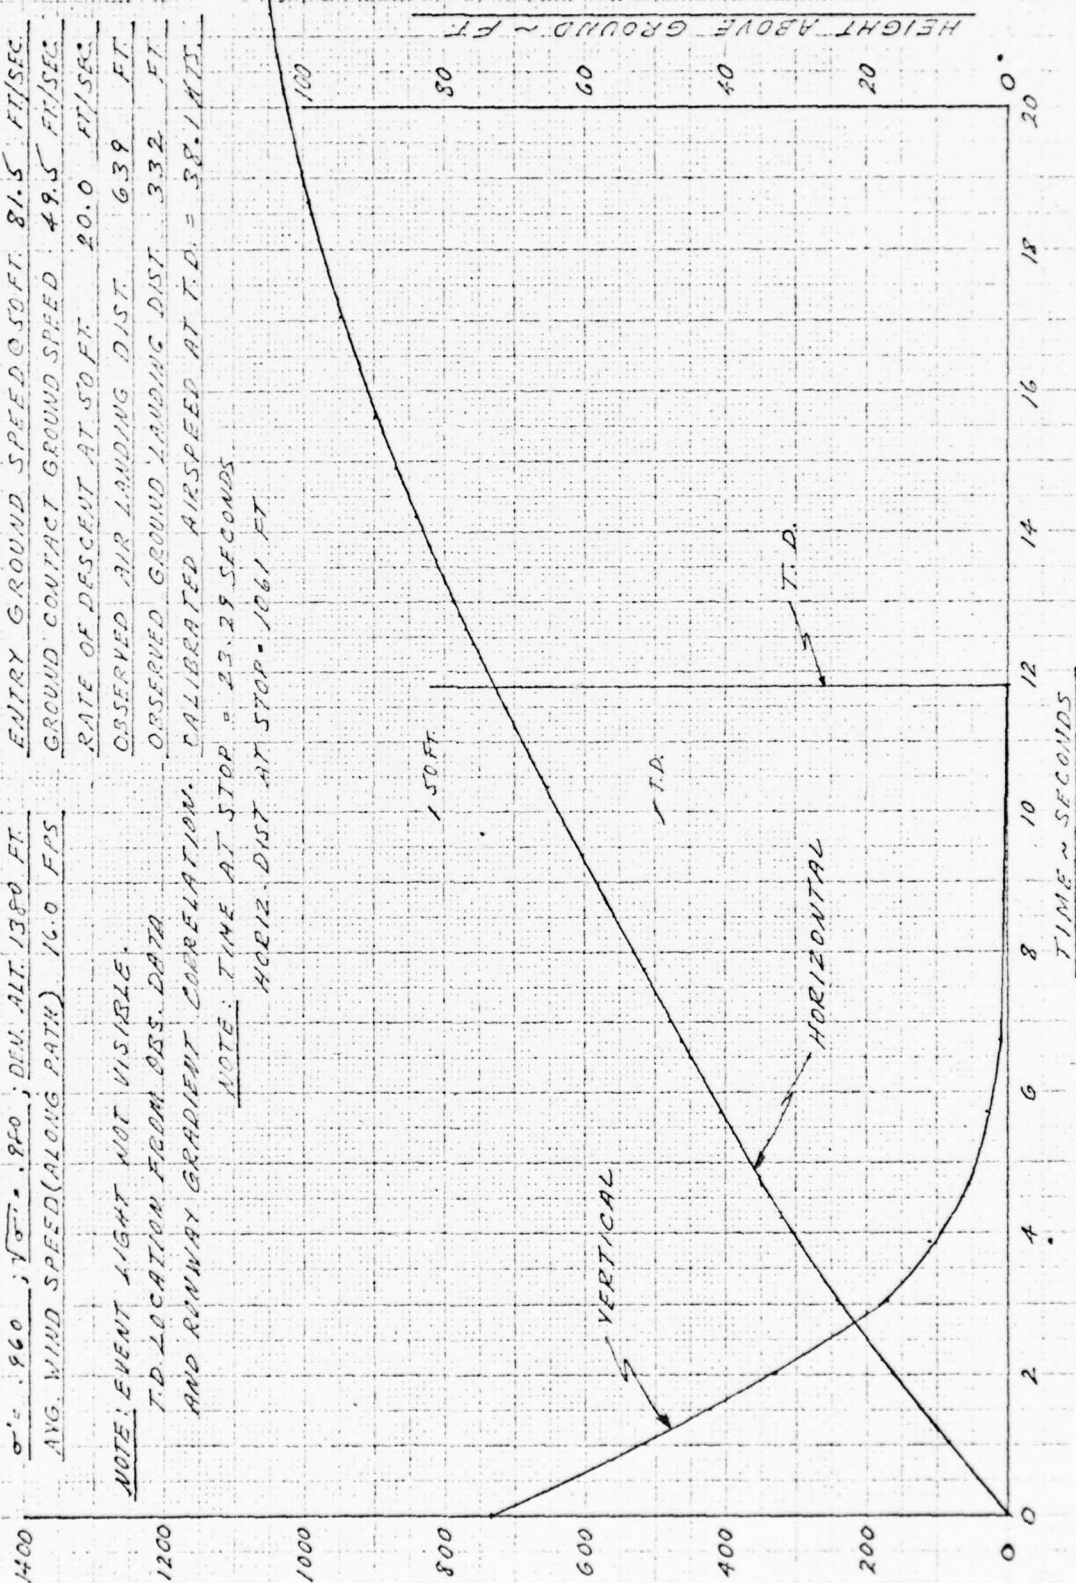
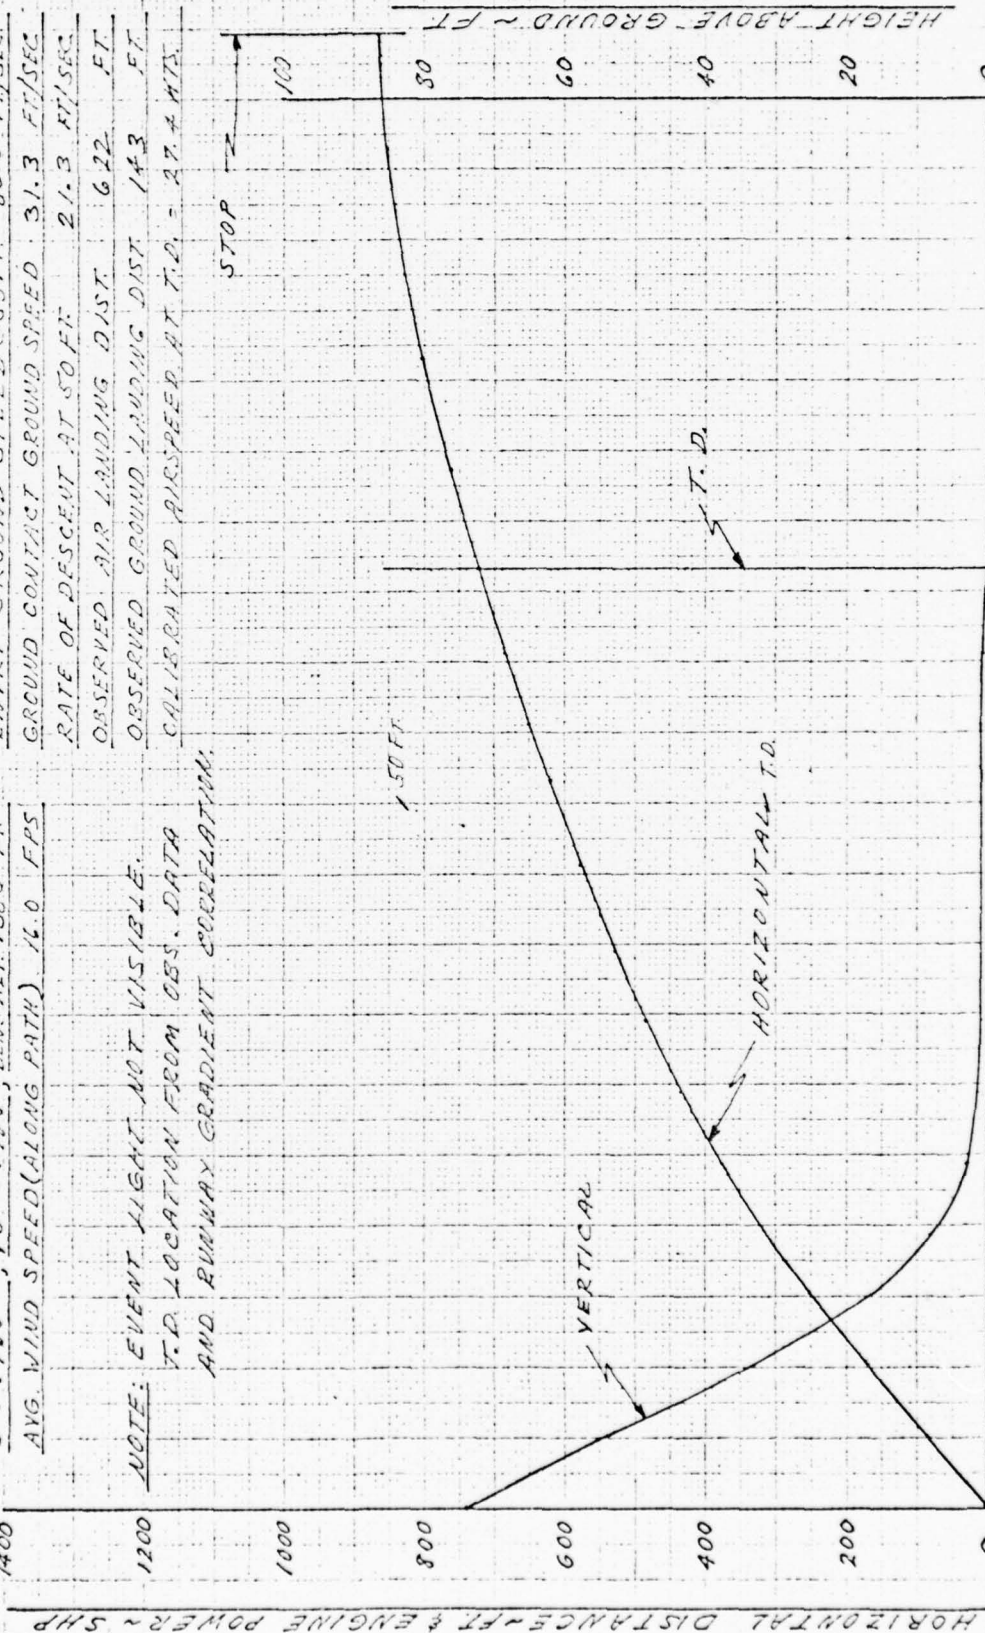
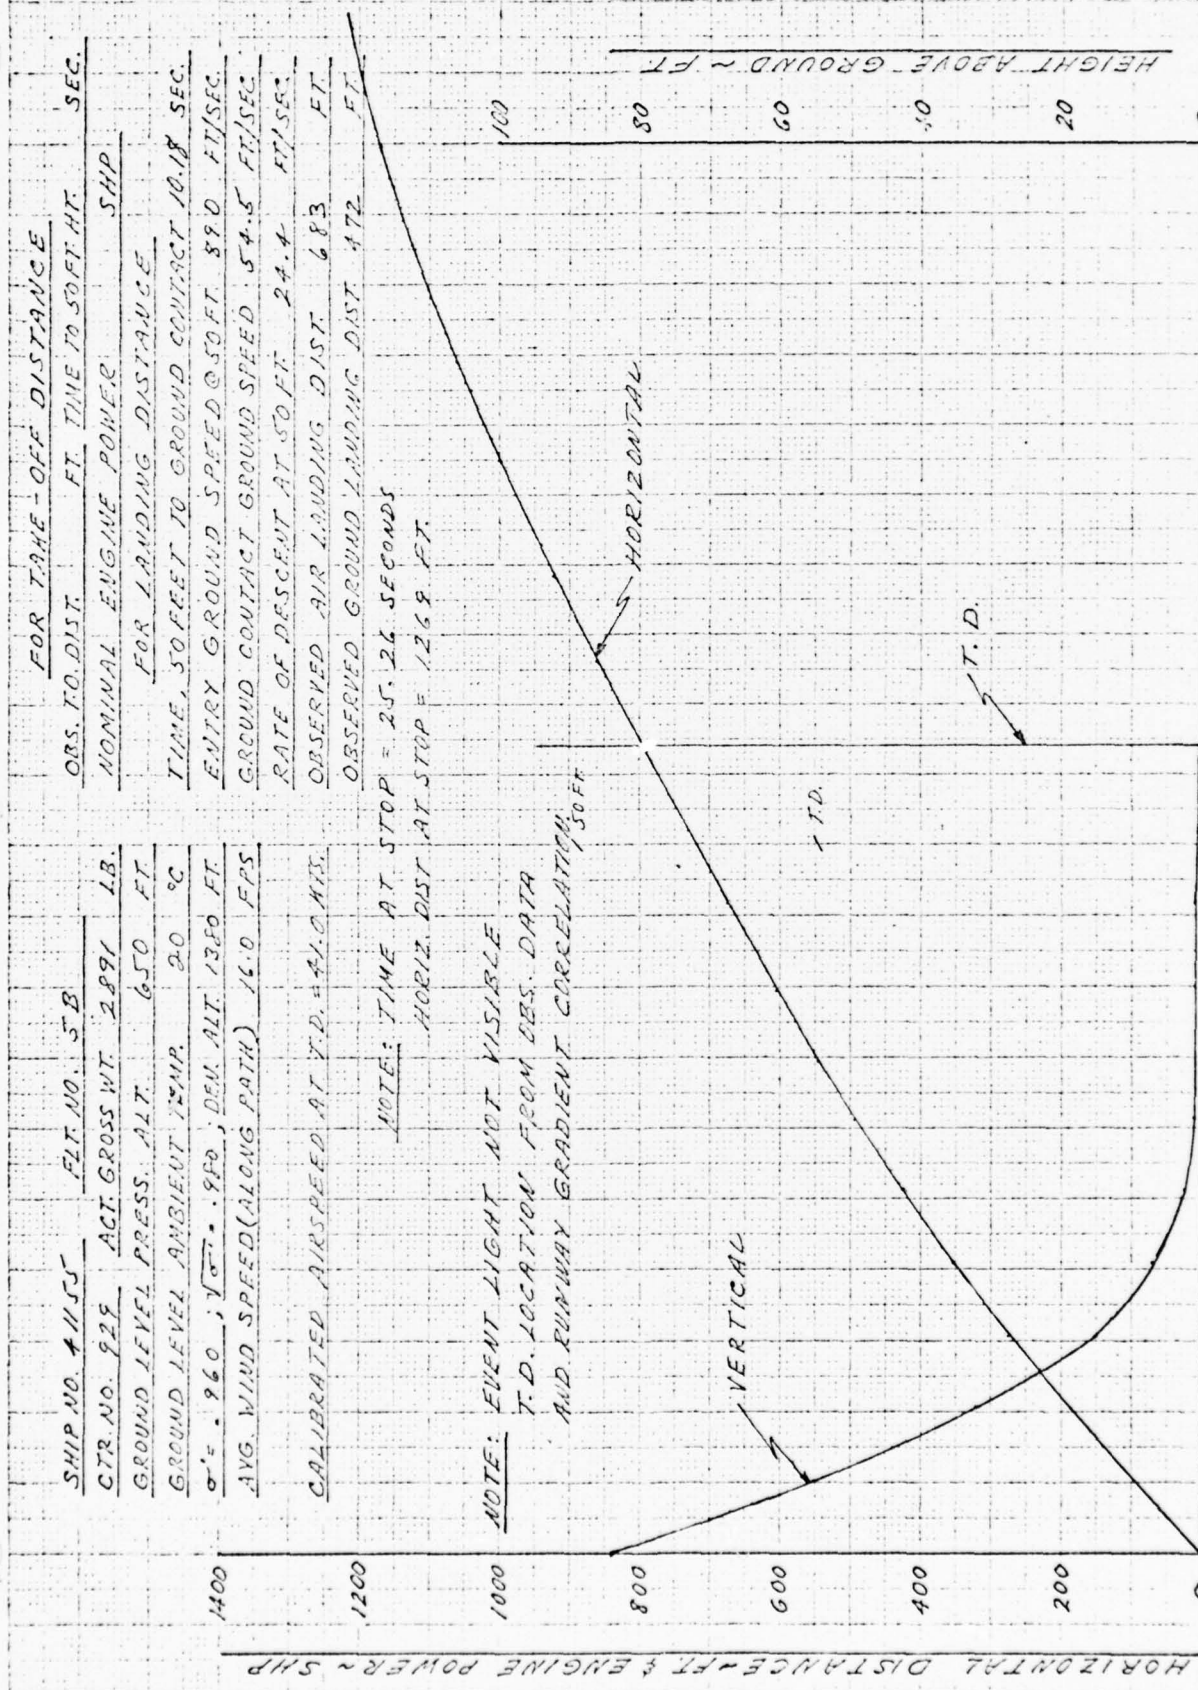
Six autorotation landings were accomplished with the available collective pitch reduced by approximately 20 percent, and Figures 25 through 30 present the data obtained by using the Federal Aviation Administration (FAA) Runk Grid Camera. Touchdown calibrated airspeed varied from 24 knots to 41 knots. Table III presents important oscillograph parameters recorded during the autorotation landings.

Reduced Collective Evaluation: After reviewing the options available, indications were the best solution to the problem was that improper autorotative techniques needed revising. However, in the event the ship were landed improperly it was judged that a reduction of the collective range would be beneficial. As a result, a Model OH-58A Helicopter, S/N 41155, was instrumented and a series of tests were begun to determine the feasibility of limiting the available collective pitch during autorotation landings (Option 3). This reduction was accomplished by attaching an adjustable cable on the copilot collective stick that physically limited the maximum up position of the collective, see Figure 23. Figure 24 shows the results of a hangar calibration of collective stick position versus main rotor blade angle. A series of hovering throttle chops, slide on landings, and autorotation touchdowns at various percent of collective reduction were evaluated to determine if a reduction in the available collective would prohibit maintaining adequate height-velocity margins. During the hovering throttle chops at a gross weight (GW) of 3000 pounds, there was a definite change in the character of main rotor blade stall when the available collective blade angle was reduced to 75 percent; however, time airborne, which is an indicator of rotor capability, was also reduced. At 80 percent available collective the time airborne after throttle chop was adequate, 3.6 seconds, and pylon motion and main rotor flapping were greatly reduced.

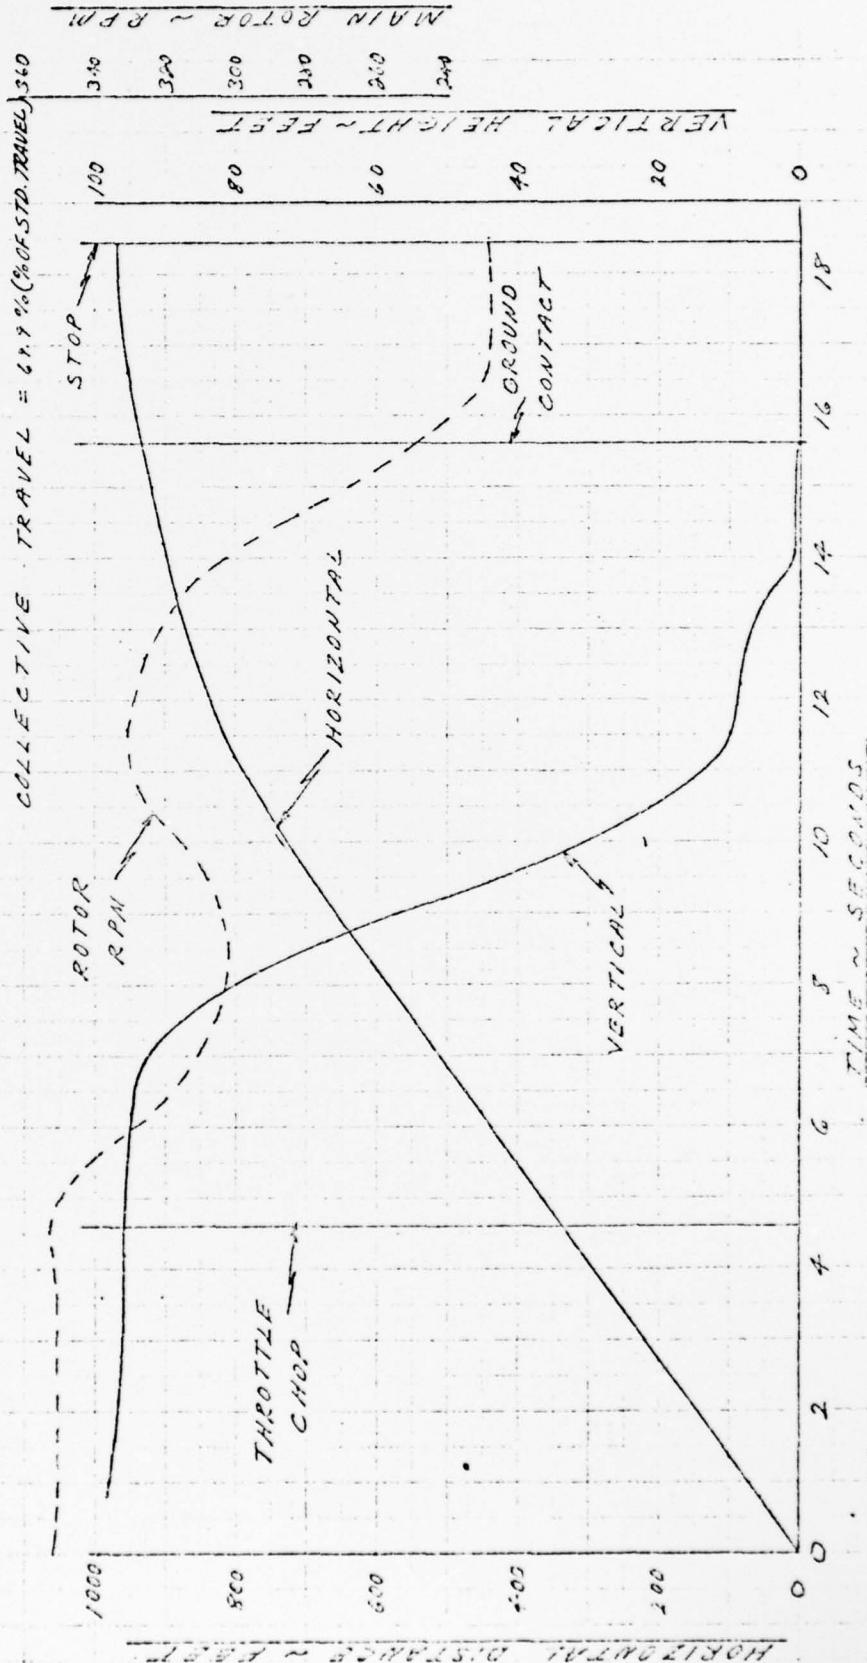
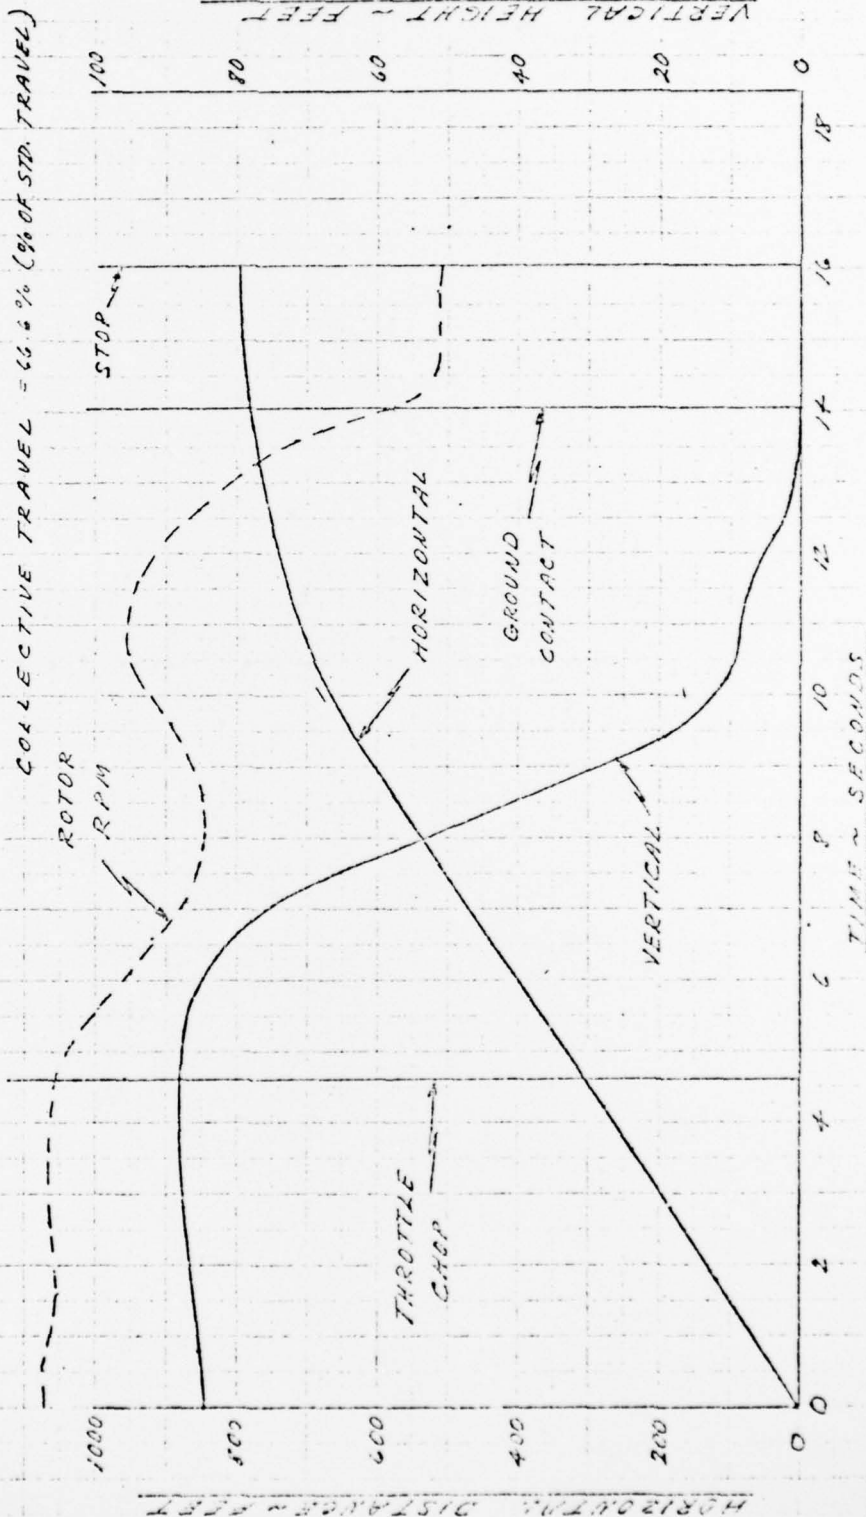
The Army test team also conducted tests to determine if the present height-velocity margins could be maintained when the available collective range was reduced to avoid excessive dynamic loading. Data were obtained by using the FAA Runk Grid Camera and results are presented in Figures 32 through 34. Table IV presents the height-velocity time history data. Figure 35 shows the runway gradient at the test site. Maximum available collective was limited to 85 percent. Results of the evaluation indicated that the maximum collective utilized during the autorotation was 70 percent and as a result, shows that adequate collective is available to maintain present height-velocity margins at the altitude the test was conducted.
